EMR AEROSPACE SCIENCES
5012 COLLEGE AVE
COLLEGE PARK, MD.

IMP J
SUMMARY TECHNICAL
REPORT
DECEMBER 1973

CONTRACT NO. NAS 5-11211

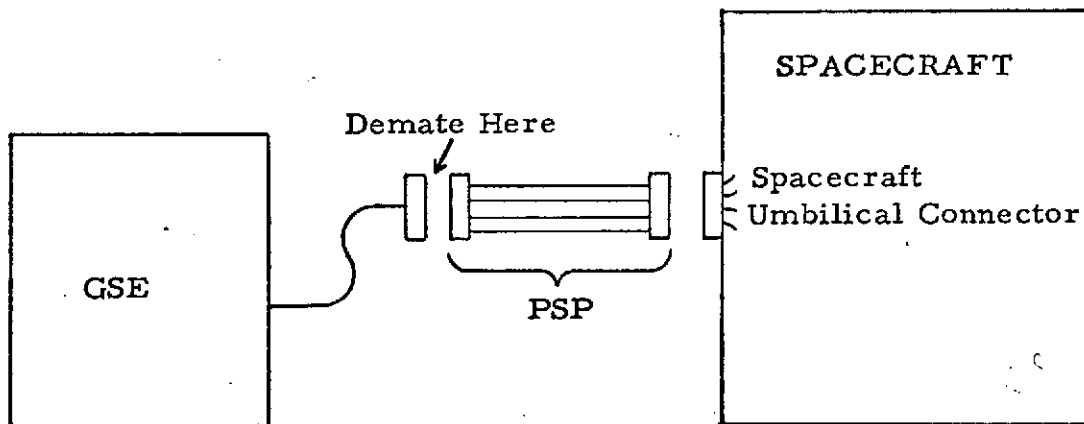
Some electrical connections to the spacecraft were mated and demated several times a day. This handling over a period of time can degrade the spacecraft mounted connector. Specifically, the umbilical and GSE test connectors were exercised regularly. To avoid damage to these connectors, a short extension, designated Pin Socket Protector (PSP), was attached and left connected to the spacecraft connector. The make and break connection was then secured at the non-spacecraft end of this short extension. Thus, any connector damage would be confined to the PSP.

The PSP protection of spacecraft connectors saved some rework time since it was anticipated that the excessive mating and demating would have degraded the spacecraft connectors.

For future spacecraft, an evaluation should be made of those areas where the PSP could effectively be employed. However, occasional testing without the PSP's should be performed to ensure that the connection without PSP's works properly.

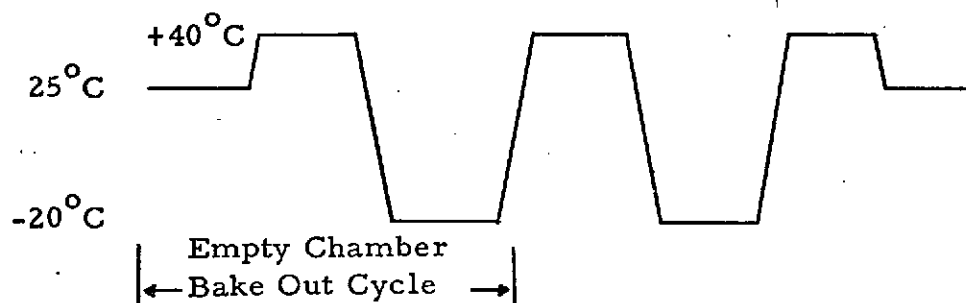
Figure 1. Vacuum Chamber Temperature Cycle

Precautions b, c, and d listed at the beginning of this section, and requiring a clean vacuum chamber, a clean spacecraft, and a sufficient time-pressure factor, have been implemented for IMP J. However, continued attention should be paid to these areas. It is recommended that the vacuum chamber be "baked out" prior to installing the spacecraft for a thermal vacuum test. Two choices are available for this "bake out". One choice is to use the same temperature cycle for the empty vacuum chamber as the first cycle will be for the spacecraft (see Figure 1). An advantage of this cycle is that the pressures encountered with the chamber empty can then be correlated to the

pressures with the chamber containing the spacecraft. This result could give an indication of spacecraft outgassing. The other choice is to "bake out" the empty vacuum chamber at as high a temperature as practicable and for as long as reasonable (24 hours to 48 hours).
